WETLAND DELINEATION REPORT

TOWN OF KEARNY
CITY OF JERSEY CITY
CITY OF BAYONNE
CITY OF HOBOKEN
TOWNSHIP OF WEEHAWKEN
HUDSON COUNTY, NEW JERSEY

New Jersey Transit
One Penn Plaza East
City of Newark, New Jersey 07105

BEM Systems, Inc.
100 Passaic Avenue
Chatham, New Jersey 07928

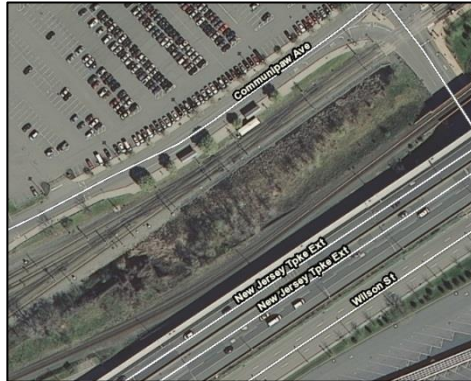
Photograph 1 – Field verified wetland area between the HBLR Line and the New Jersey Turnpike.

While wetlands were observed, the wetland area is bound from the HBLR right-of-way by a concrete retaining wall and chain link fence. Furthermore, the wetlands are anticipated to be either ordinary or intermediate resource value (N.J.A.C. 7:7A-2.4), with 50-foot transition areas. As such, in this location of the HBLR Line characteristic wetlands are found adjoining the HBLR ROW and but the wetland transition area is already an altered and ballasts developed area.

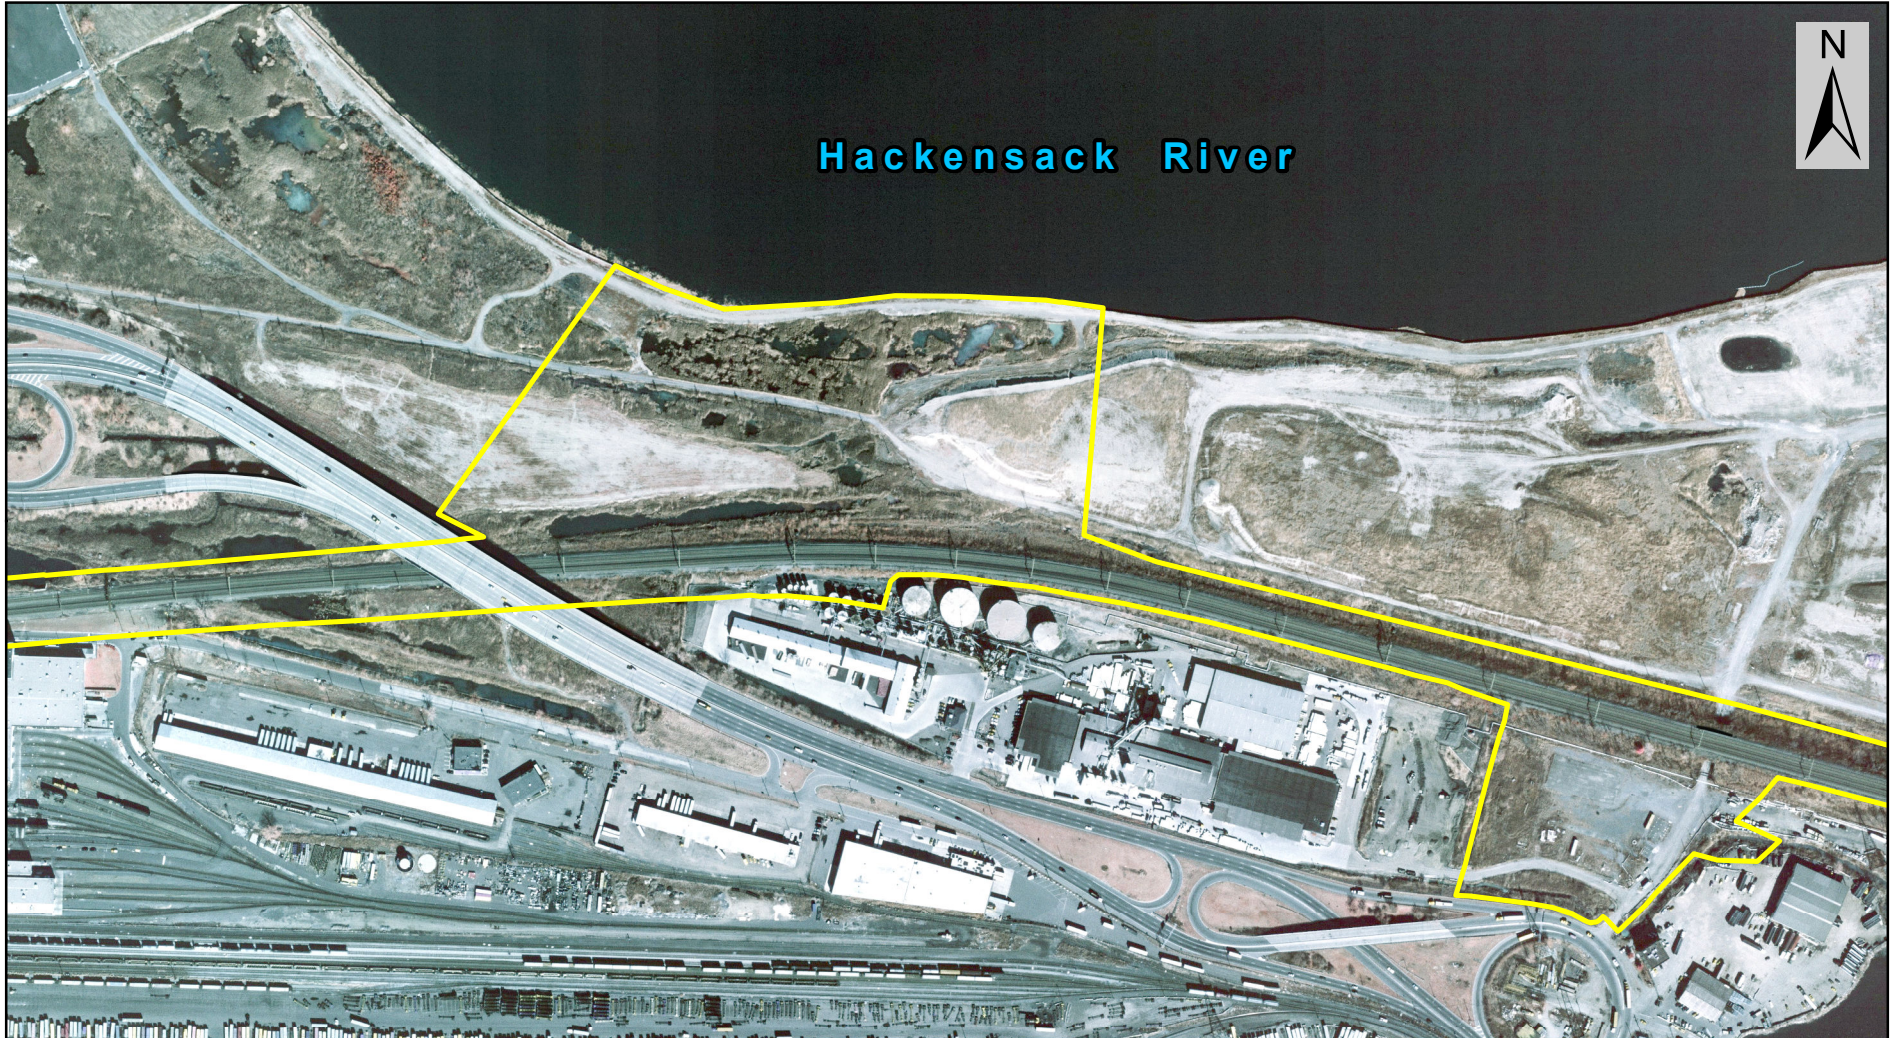
Figure 4: Historic Aerial - 2002

The Koppers Koke Site was once used as a coal tar processing plant in the early 1900s. Throughout the 1900s, the Koppers Koke Site had been redeveloped and repurposed for industrial activities, up until the 1990s when use of the Koppers Koke Site was discontinued (**Figures 3 and 4**). From the 1990s until 2008, the land was left unused, and successional vegetation and wetland environments began to reclaim the maintained land. However, in 2008 remediation activities commenced, as outlined in the 2007 Remedial Action Work Plan Addendum (RAWPA), and included the placement of Processed Dredge Material (PDM) across the majority of the property in order to raise the surface elevation to at least 10 feet above mean seal level to minimize flood risk on the property, as the property is located within the floodplain of the Hackensack River. However, the PDM fill was not placed along the northern and southern boundary of the Main Evaluation Area, which is where BEM wetland scientists field verified the presence/absence of wetlands/waters during a 2016 field investigation.

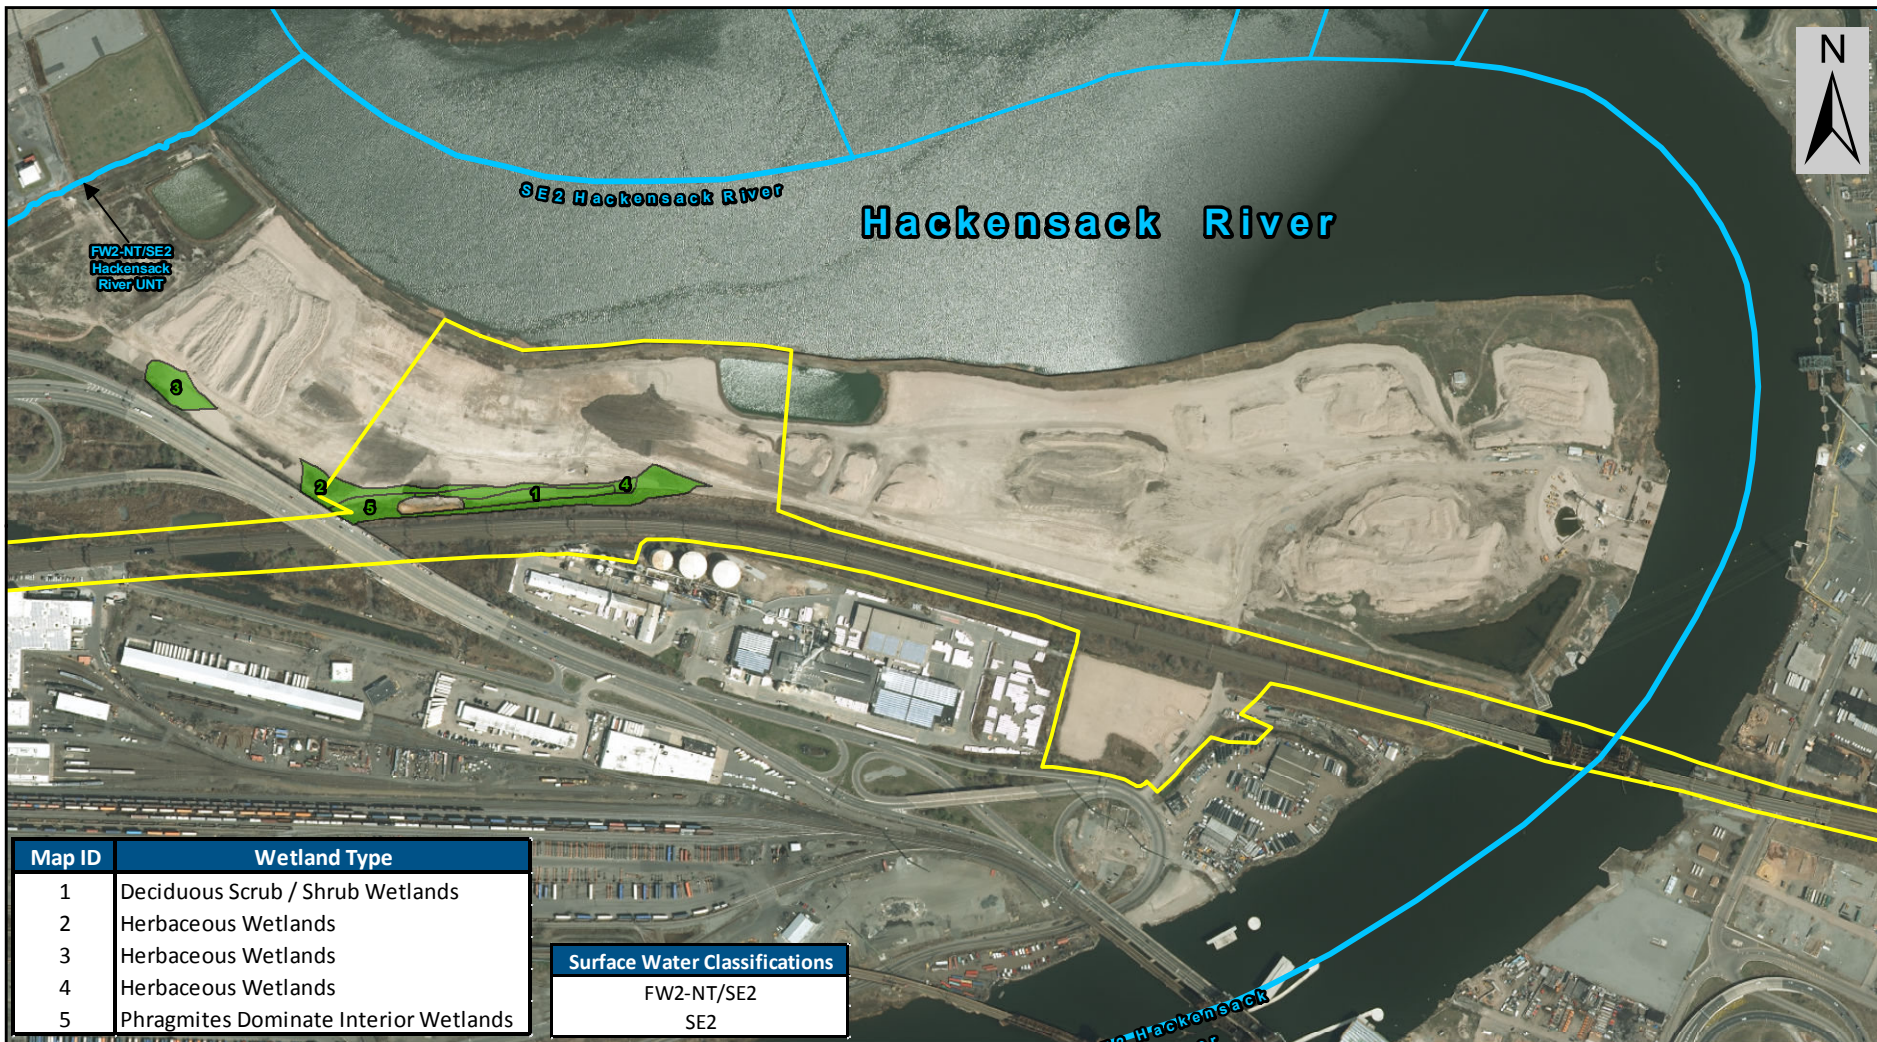
Map ID	Wetland Type
1	Deciduous Scrub / Shrub Wetlands
2	Herbaceous Wetlands
3	Herbaceous Wetlands
4	Herbaceous Wetlands
5	Phragmites Dominate Interior Wetlands

Surface Water Classifications
FW2-NT/SE2
SE2

In the 2016 *Morris and Essex Rail Line Wetland Delineation Report* prepared by Amy S. Greene Environmental Consultants, Inc. (**Attachment C**), assets along the Morris and Essex Line were field investigated for the presence or absence of wetlands within and adjacent to the line's right-of-way. During the field delineation, no wetland resources were observed at the location of the Hackensack Crossing area, both directly adjacent to the Hackensack River, and upland of the River (**Figure 1, Drawing NR-002**). Additionally, the NJDEP does not identify freshwater wetlands at this location, and the NWI Wetland Mapper does not identify wetlands along the banks of the Hackensack River at this location (**Figures 5 and 6**).

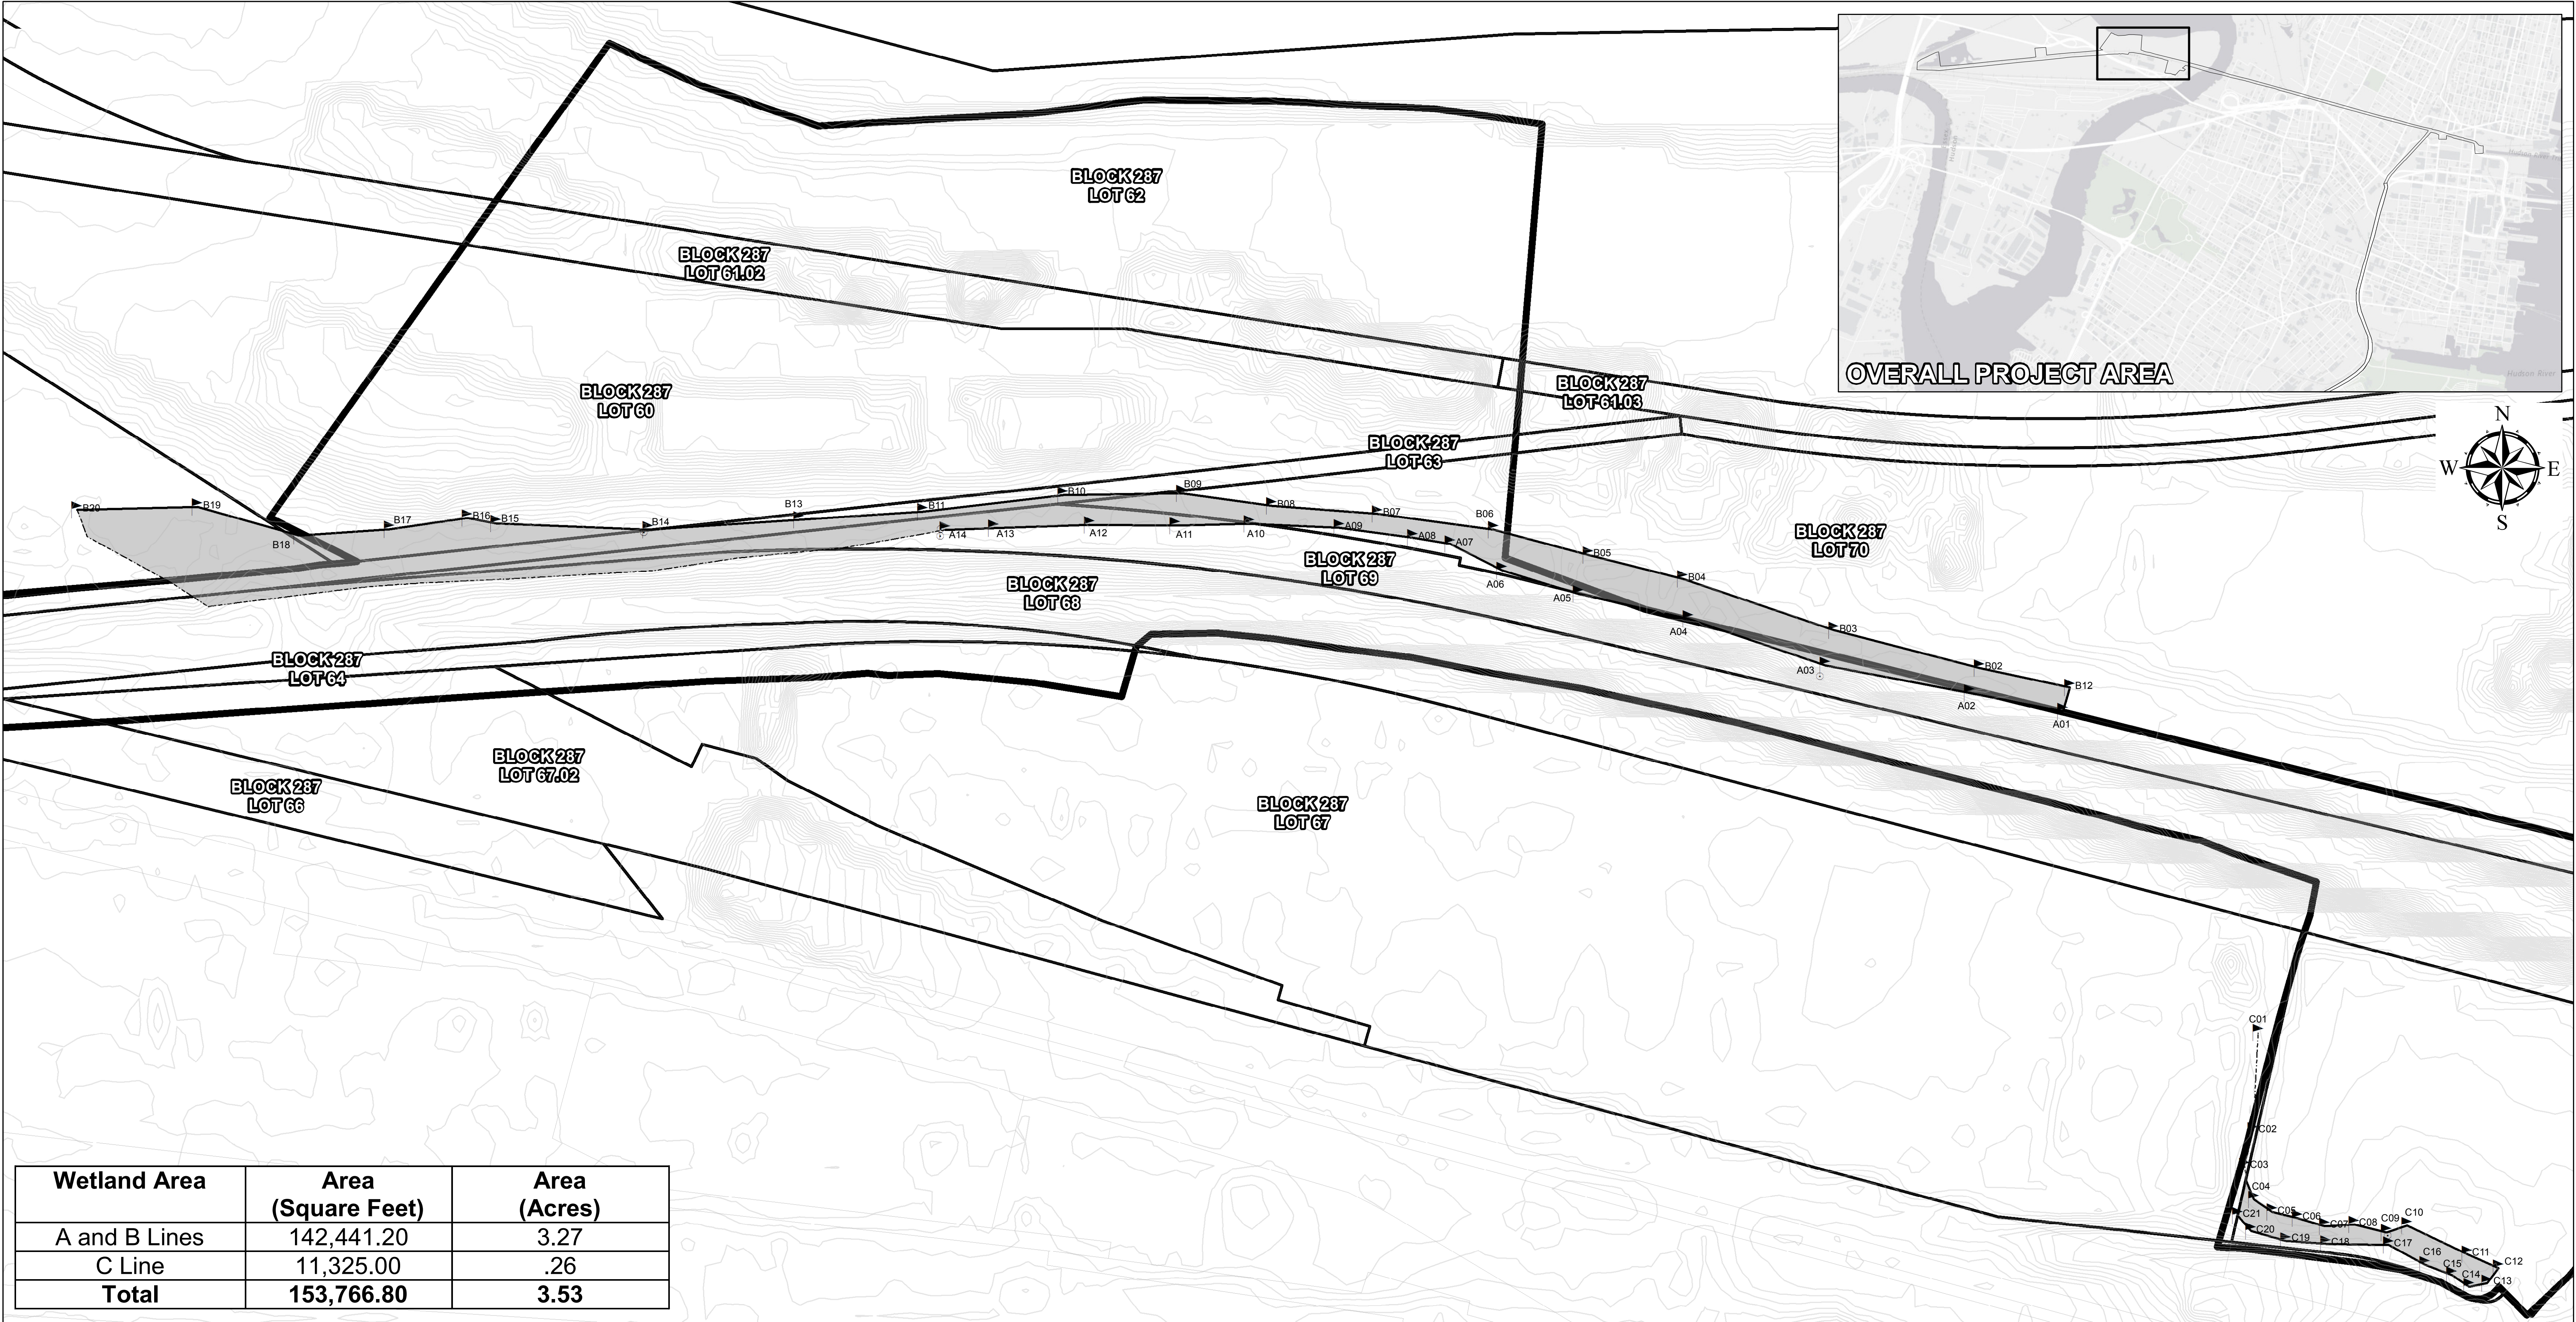
NR - 001
WETLAND DELINEATION PLAN
DRAWING 1 OF 2

Wetland Area	Area (Square Feet)	Area (Acres)
A and B Lines	142,441.20	3.27
C Line	11,325.00	.26
Total	153,766.80	3.53

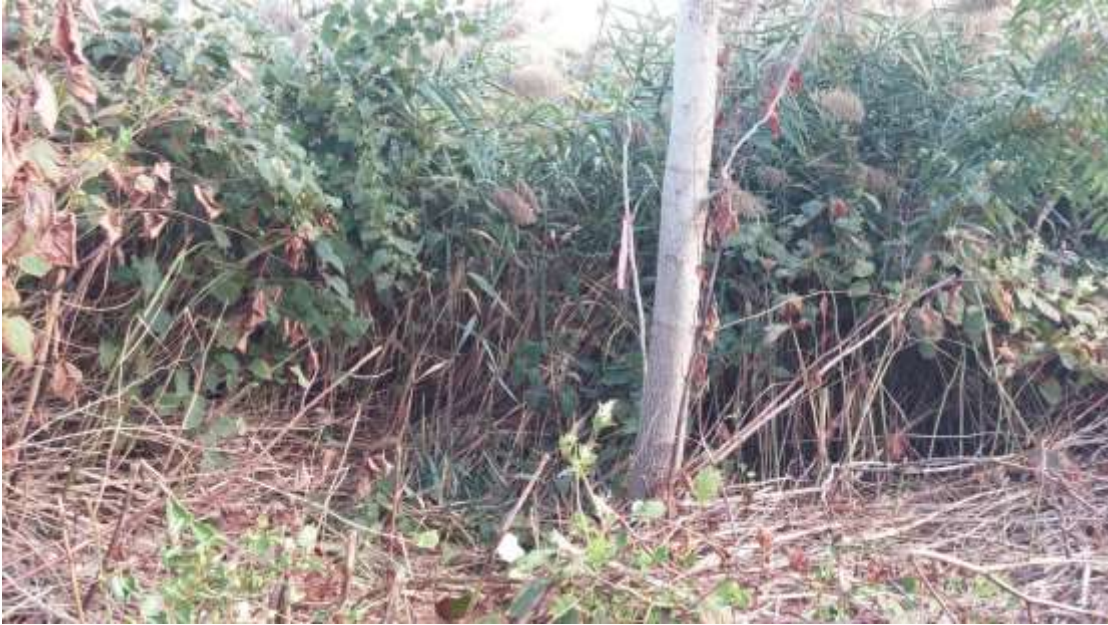
Photograph No. 1 – Taken near Flag A3, Data Point 1 Upland is surrounded by Poison Sumac and Common Reed, down a slight slope from the adjacent gravel maintenance road.

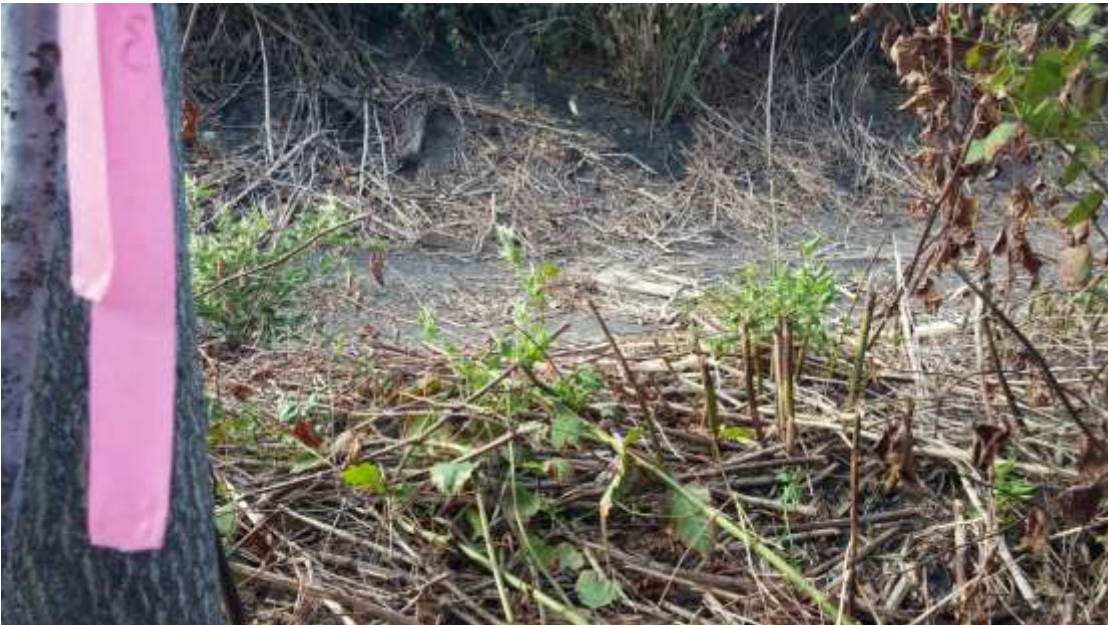
Photograph No. 2 – Taken near Flag A3, Data Point 1 Upland is surrounded by Poison Sumac and Common Reed, down a slight slope from the adjacent gravel maintenance road.

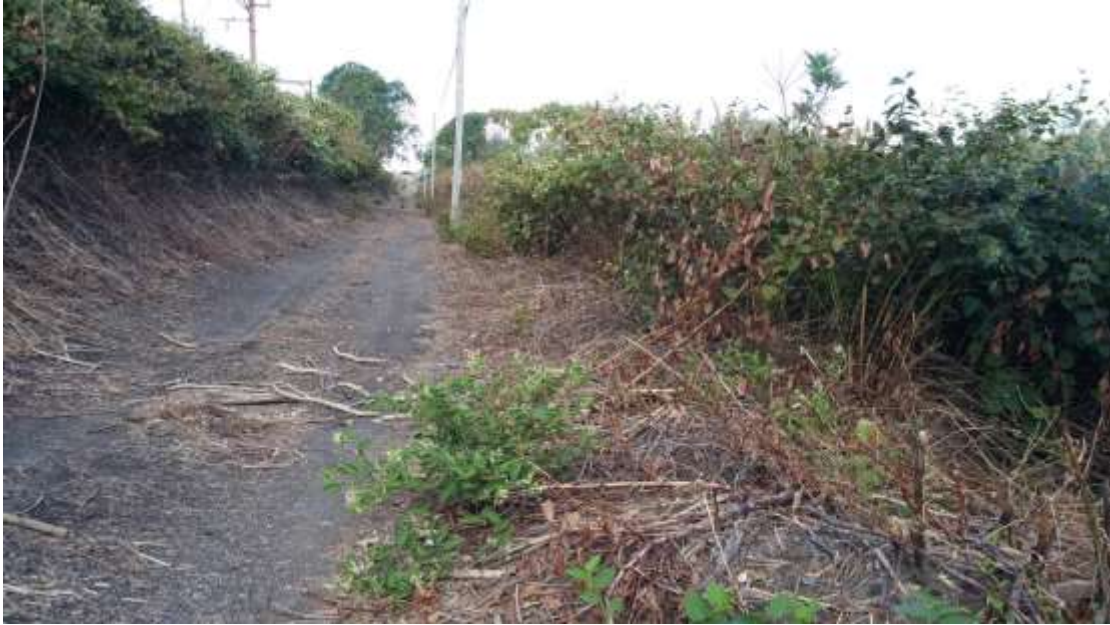
Photograph No. 3 – Gravel maintenance road adjacent to Wetland Line A, where maintained vegetation covers the slight downgrade slope to the wetland area on the right.

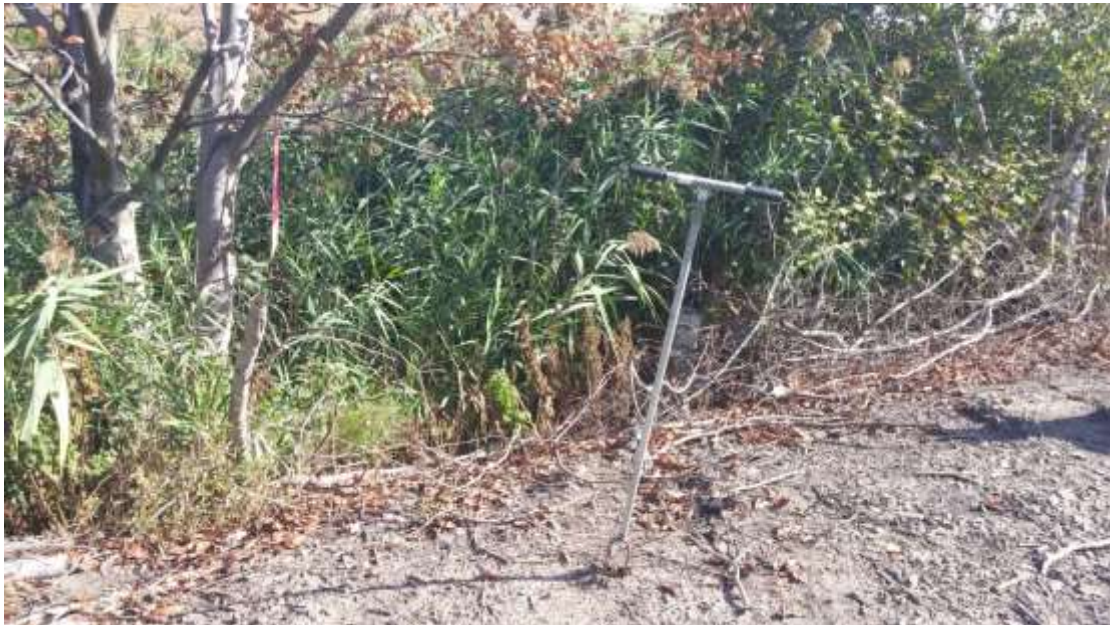
Photograph No. 4 – Taken near Flag A14, Data Points 2, Upland and Wetland, are located directly adjacent to the gravel maintenance road, and are surrounded by Common Reed and Tree of Heaven. Standing water occurs at the base of the vegetation downslope.

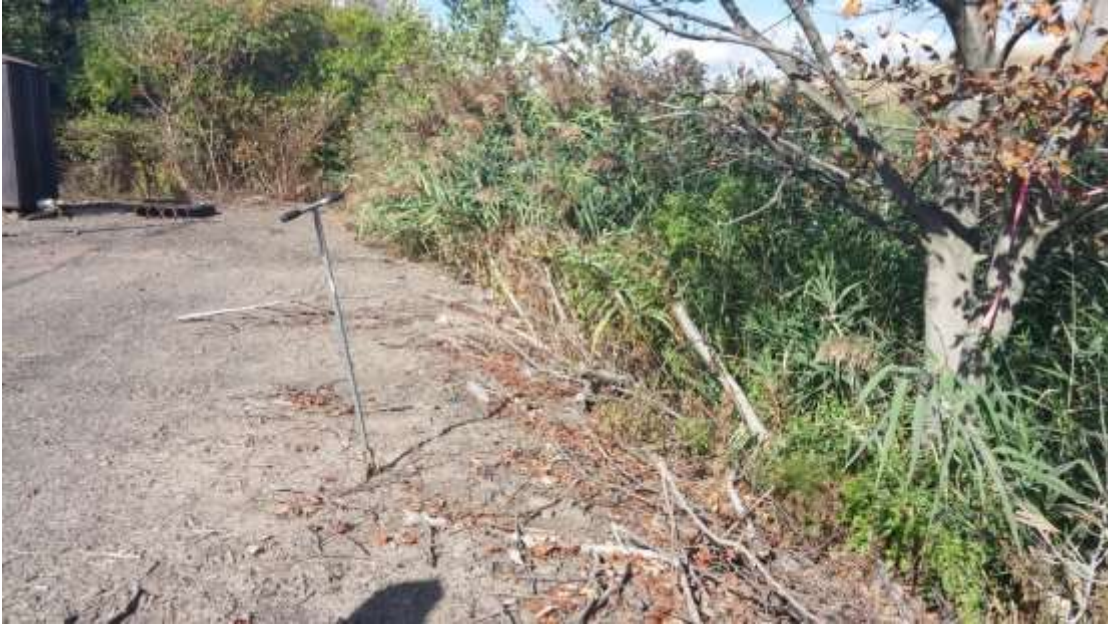
Photograph No. 5 – Taken near Flag A14, Data Points 2, Upland and Wetland, are located directly adjacent to the gravel maintenance road, and are surrounded by Common Reed and Tree of Heaven. Standing water occurs at the base of the vegetation downslope.

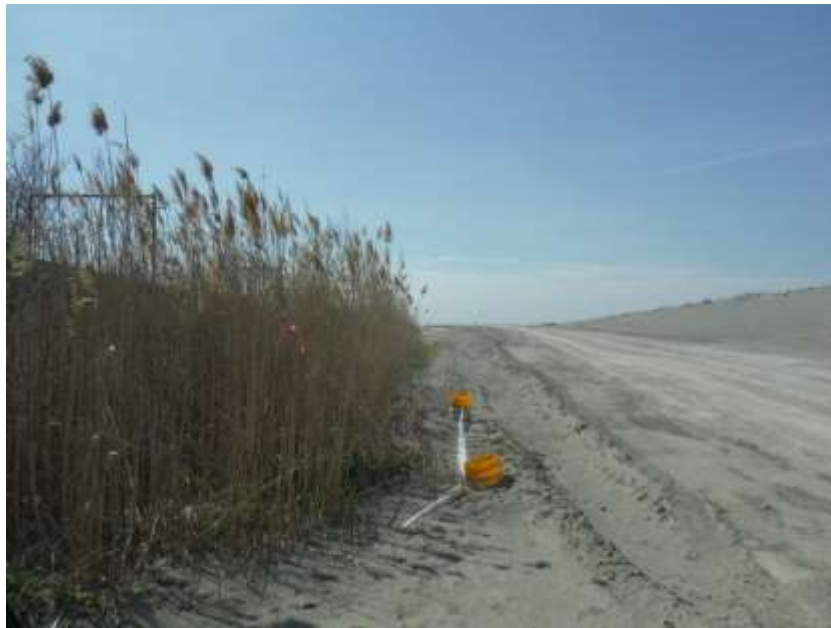
Photograph No. 6 – Taken near Flag B2, Wetland Lines A and B are located between the gravel maintenance road, and the Processed Dredge Material (PDM) fill, as shown in the picture.

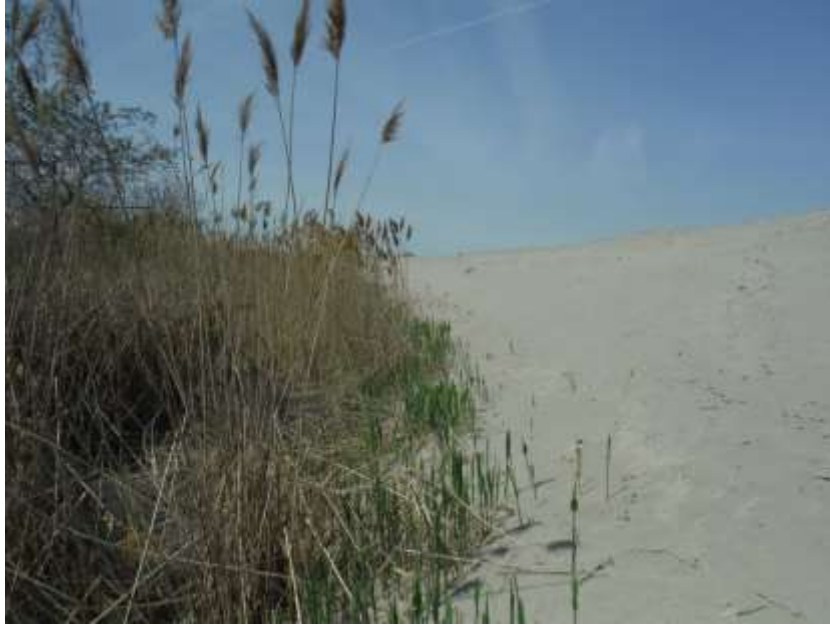
Photograph No. 7 – Taken near Flag B4, the majority of Wetland Line B, until Flag B 13, is similar to the picture, where PDM fill slopes up from the vegetation line of the adjacent wetland area.

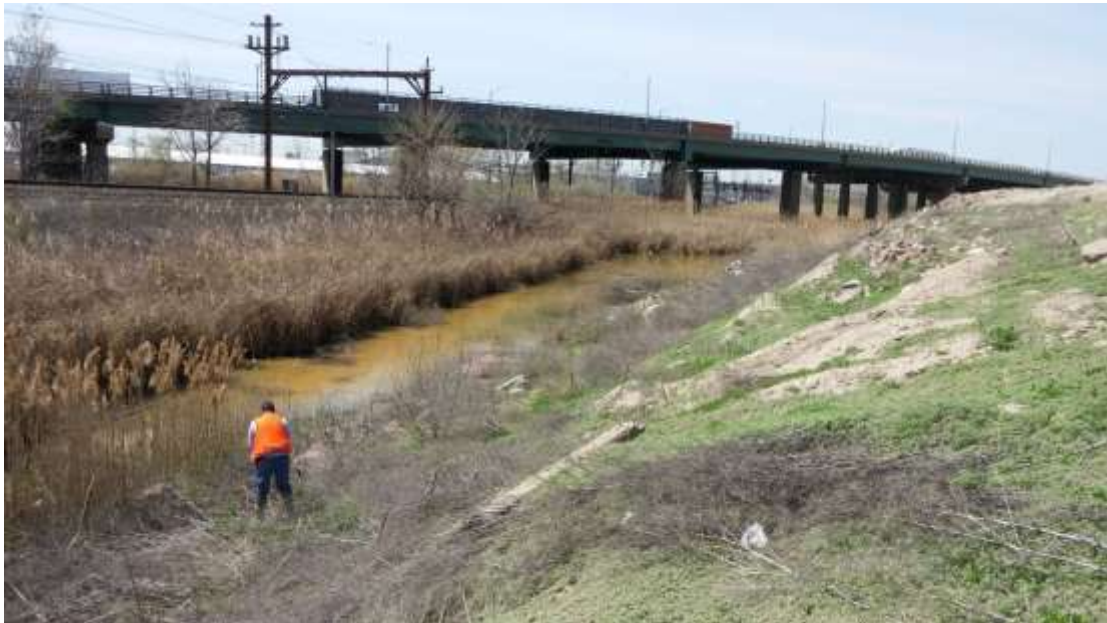
Photograph No. 8 – Taken near Flag B13, the PDM fill slope begins to show debris adjacent to the Wetland Line B.

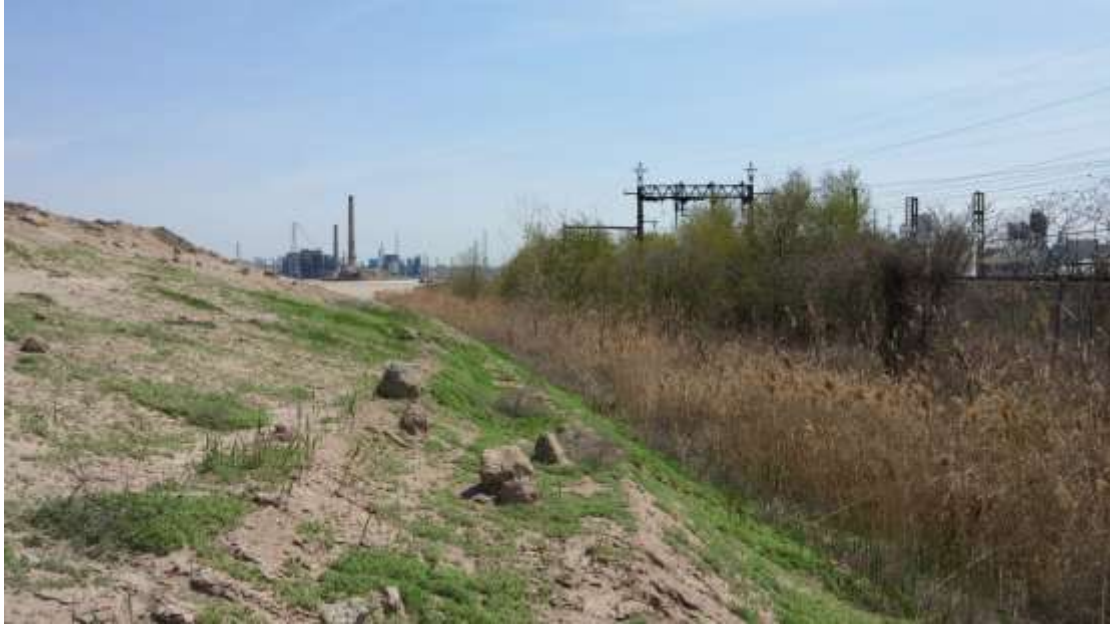
Photograph No. 9 – Overview of Wetland Line B, with PDM fill adjacent to the Line in the background, consisting of debris and maintained grass growth in the foreground.

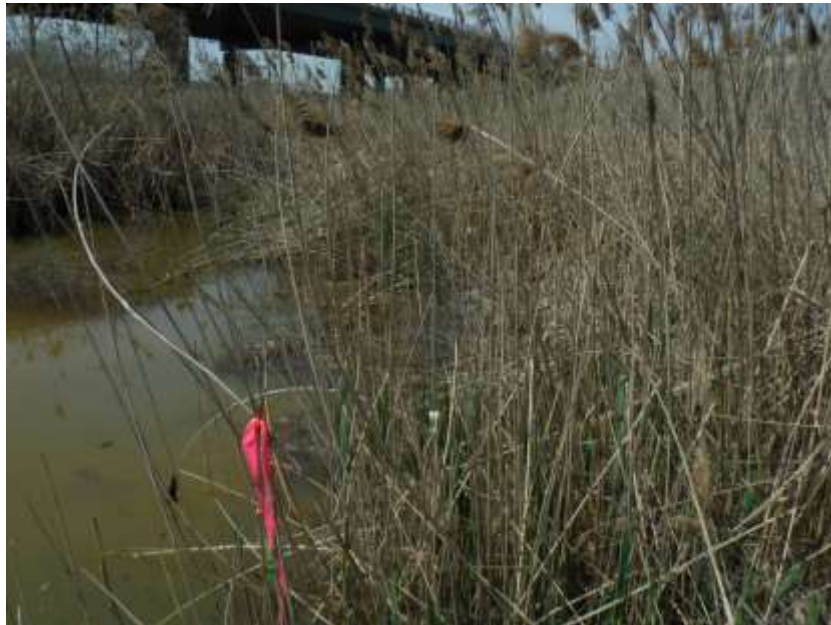
Photograph No. 10 – Taken near Flag B14, this portion of Wetland Line B consists of standing water with Common Reed dominating the surrounding vegetation. Data point 3 Wetland was taken here.

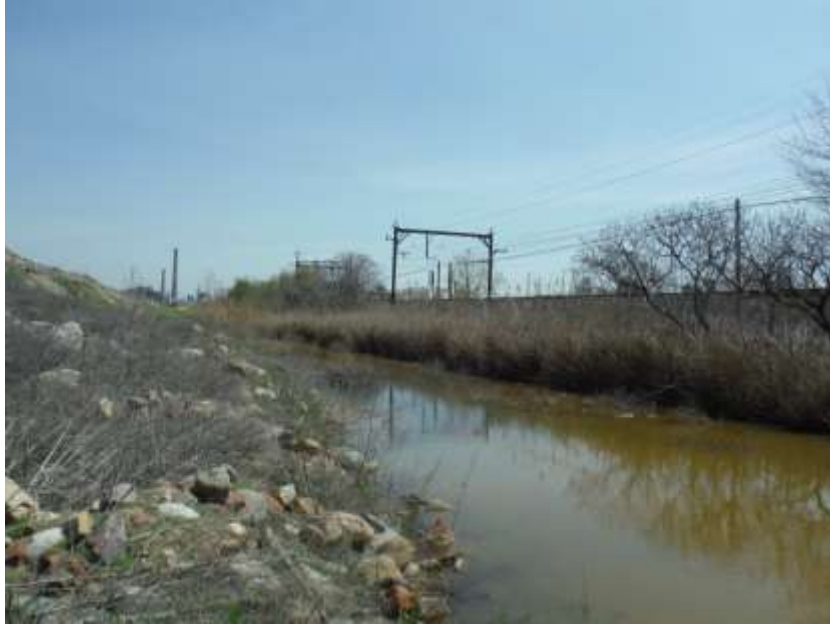
Photograph No. 11 – Taken near Flag B15, this is a continuation of the standing water wetland area, with debris and PDM fill along the adjacent slope.

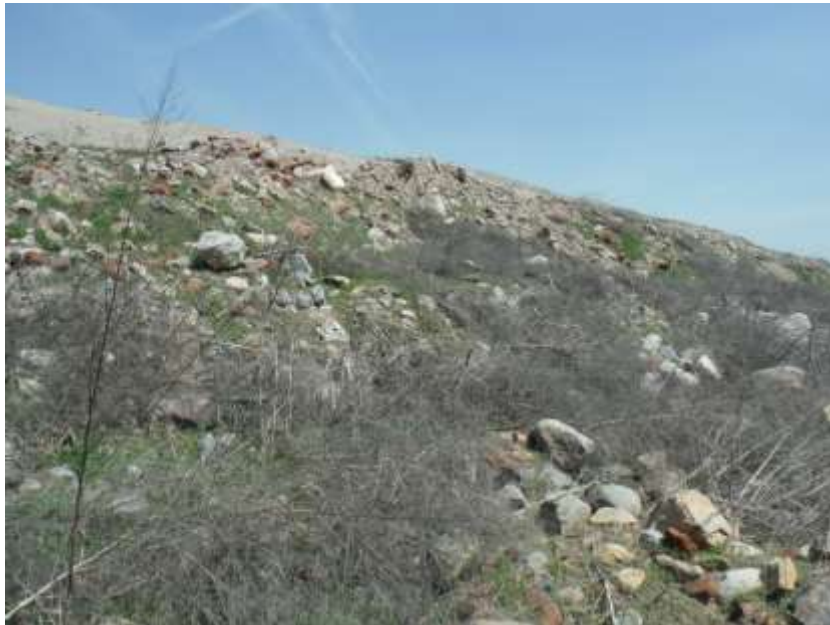
Photograph No. 12 – Taken near Flag B15, debris and PDM fill along the adjacent slope.

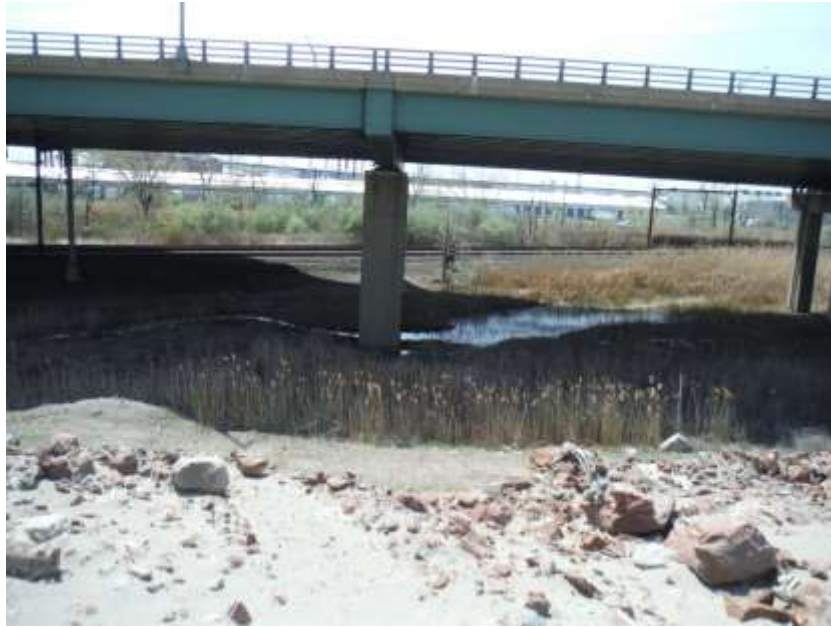
Photograph No. 13 – Taken near Flag B18, offsite wetlands beneath the Route 7 overpass. Standing water was present, and at the time, Common Reed was growing as well. On later site visits, Common Reed overgrew the wetland area, dominating the landscape.

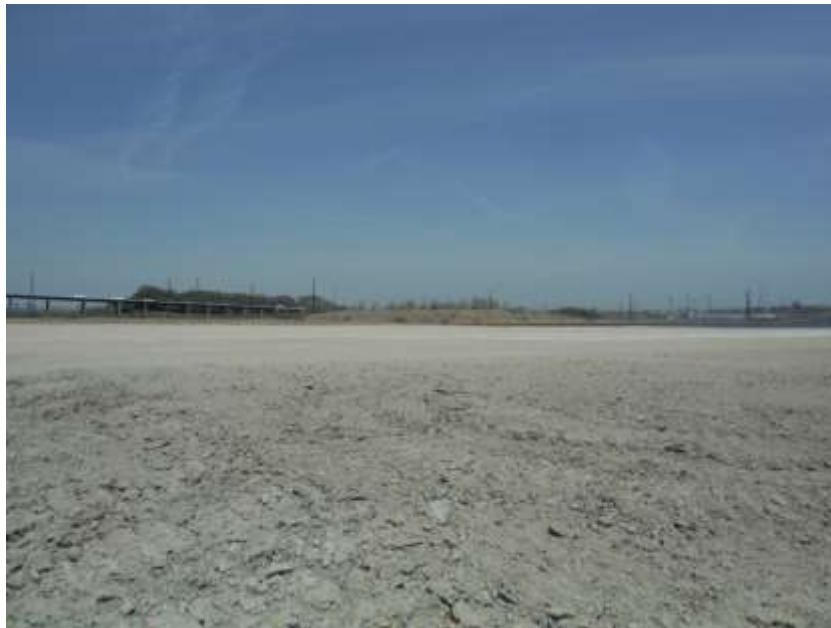
Photograph No. 14 – Taken in the center of the site on top of the PDM fill placed in 2008, facing north.

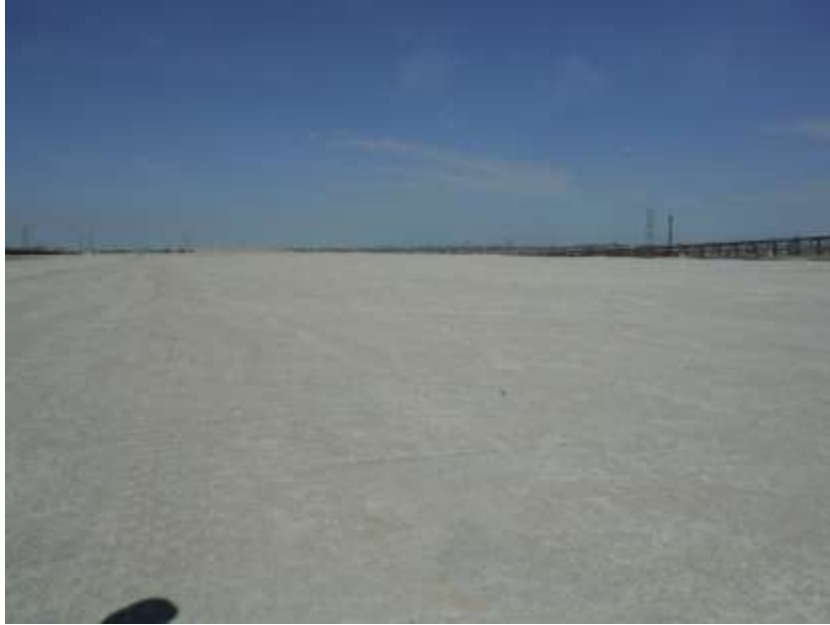
Photograph No. 15 – Taken in the center of the site on top of the PDM fill placed in 2008, facing northeast.

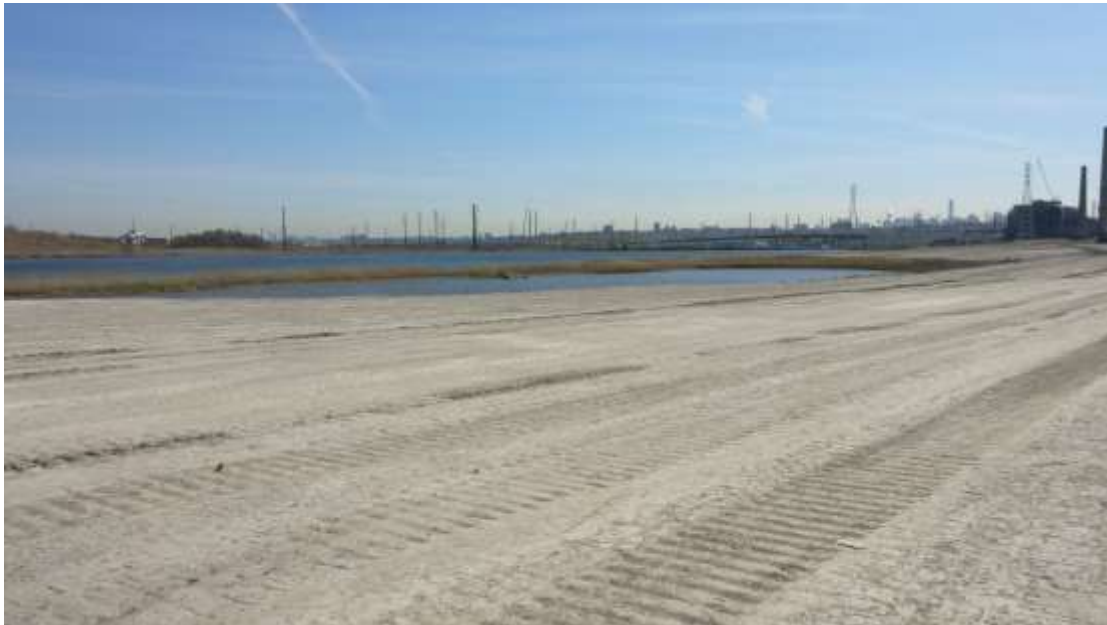
Photograph No. 16 – Taken in the center of the site, the man-made stormwater basin located directly adjacent to the Hackensack River.

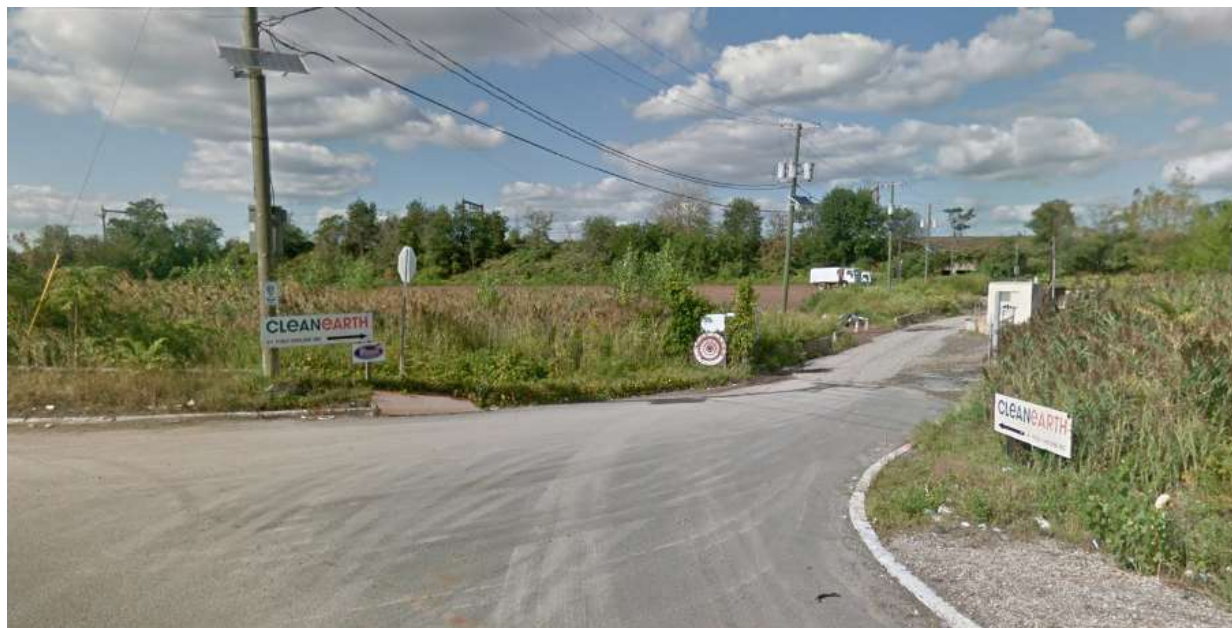
Photograph No. 17 – The entrance of the site along Fish House Road, with the 6 acre parcel in the background.

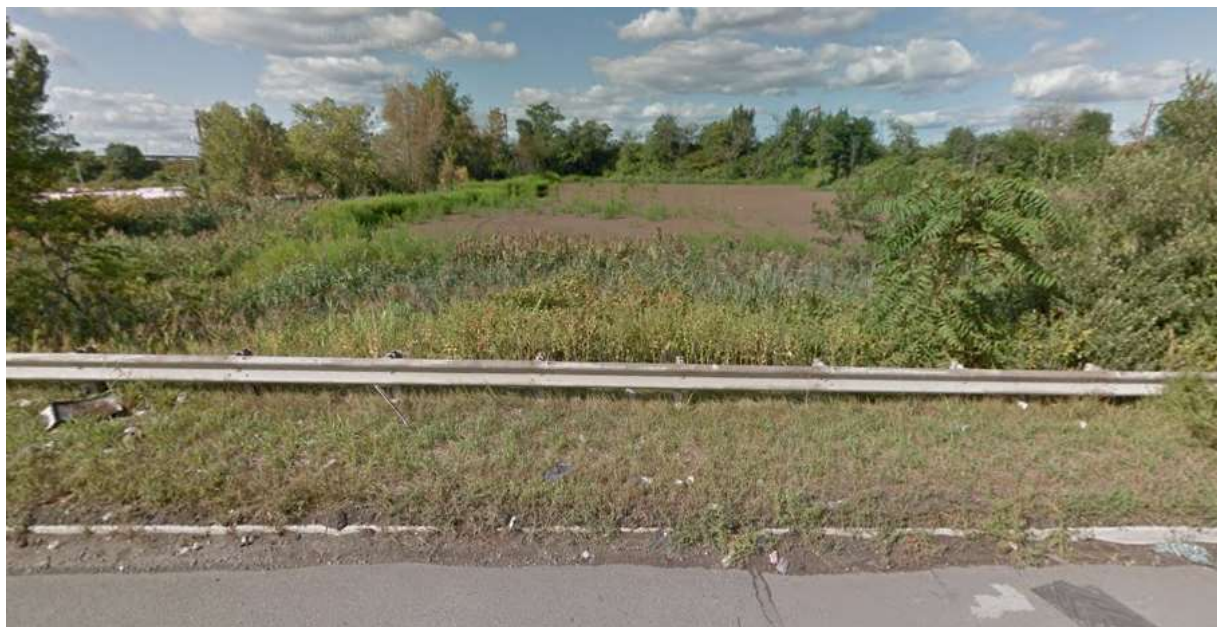
Photograph No. 18 – The 6 Acre Parcel, with the Wetland Line C area overgrown with Common Reed, as seen from Fish House Road.

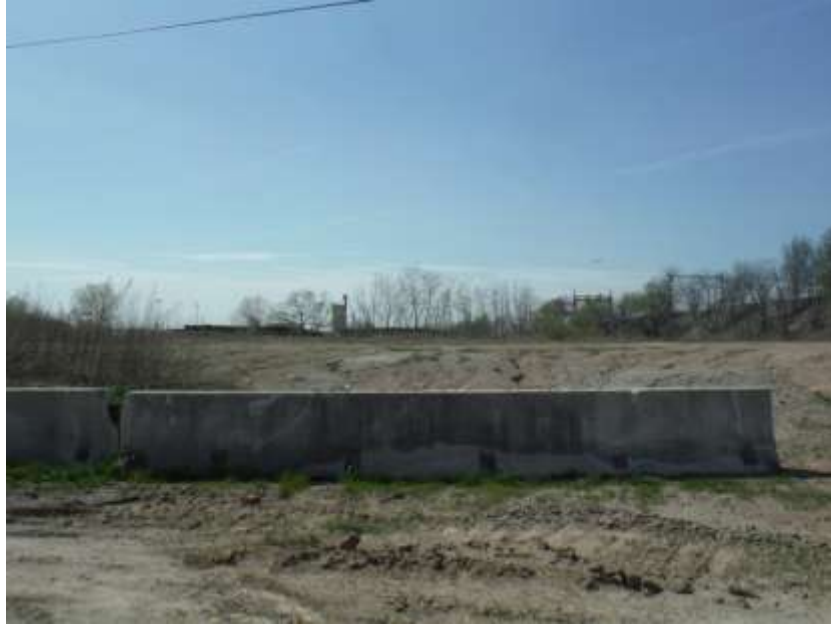
Photograph No. 19 – The 6 Acre property, devoid of vegetation where PDM fill is present. Wetland Line C and the far slopes along the perimeter of the area contain vegetation.

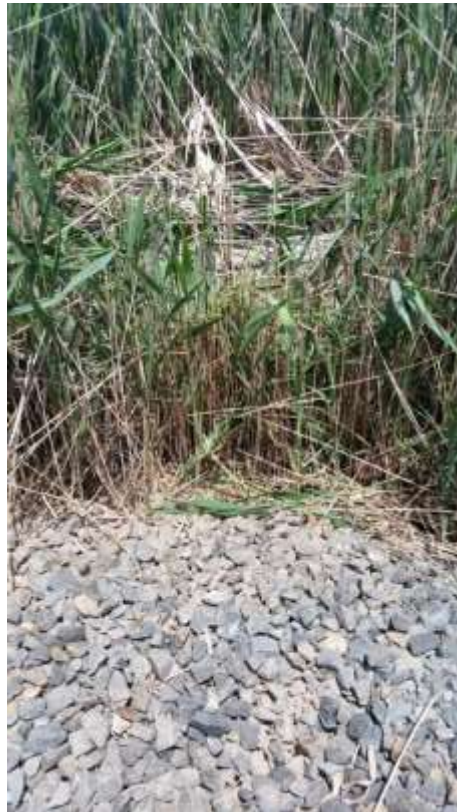
Photograph No. 20 – Wetland Line C is consistent with a manmade stormwater basin, which was at extremely low water elevations during the site visit. The stormwater outlet feature is surrounded and overgrown with Common Reed.
