WETLAND DELINEATION REPORT

TOWN OF KEARNY
CITY OF JERSEY CITY
CITY OF BAYONNE
CITY OF HOBOKEN
TOWNSHIP OF WEEHAWKEN
HUDSON COUNTY, NEW JERSEY

New Jersey Transit
One Penn Plaza East
City of Newark, New Jersey 07105

BEM Systems, Inc.
100 Passaic Avenue
Chatham, New Jersey 07928

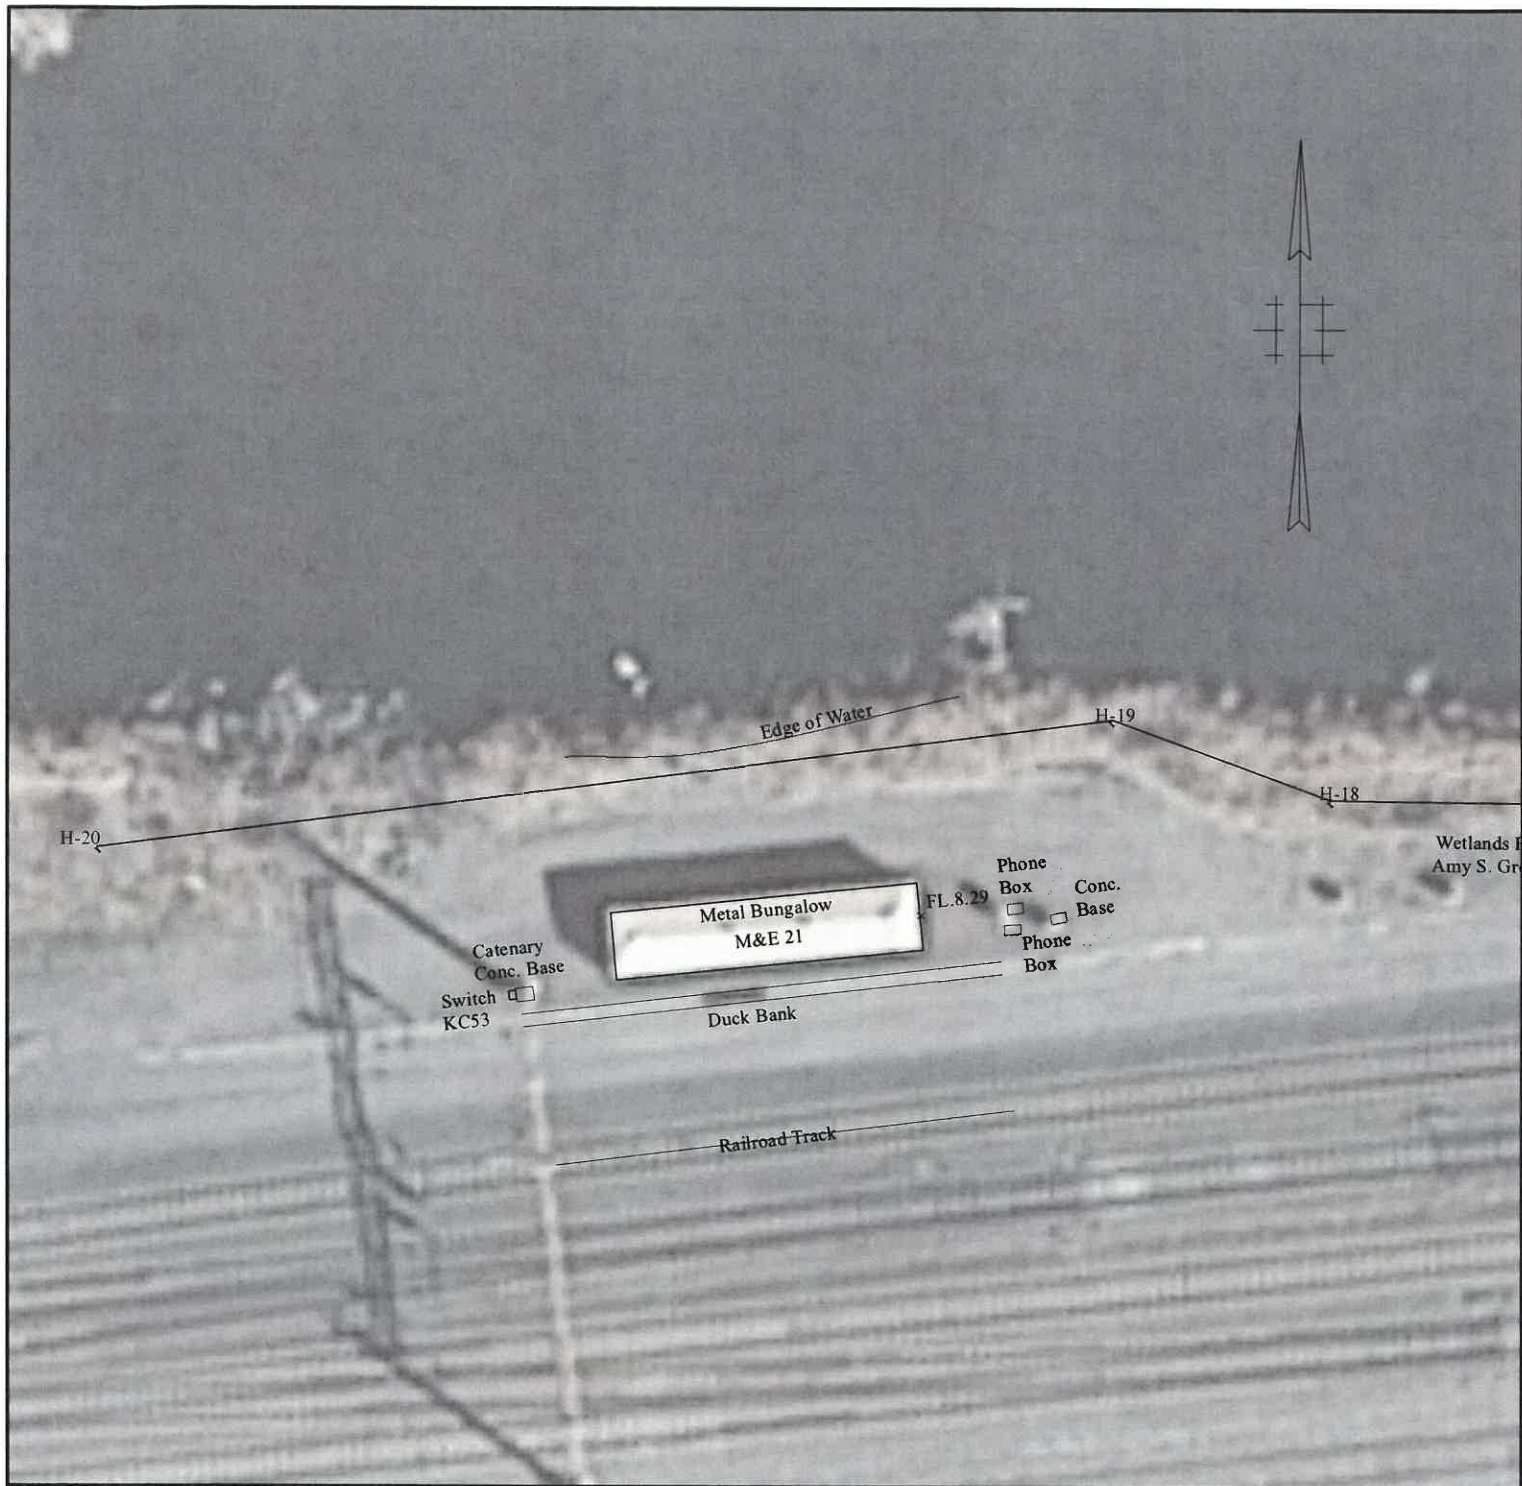
Figure 9j
Wetland Delineation Map

Asset M&E 21
NJT - Morris & Essex Line
Train Controls / Wayside Signals
Towns of Harrison & Kearny
Hudson County, New Jersey

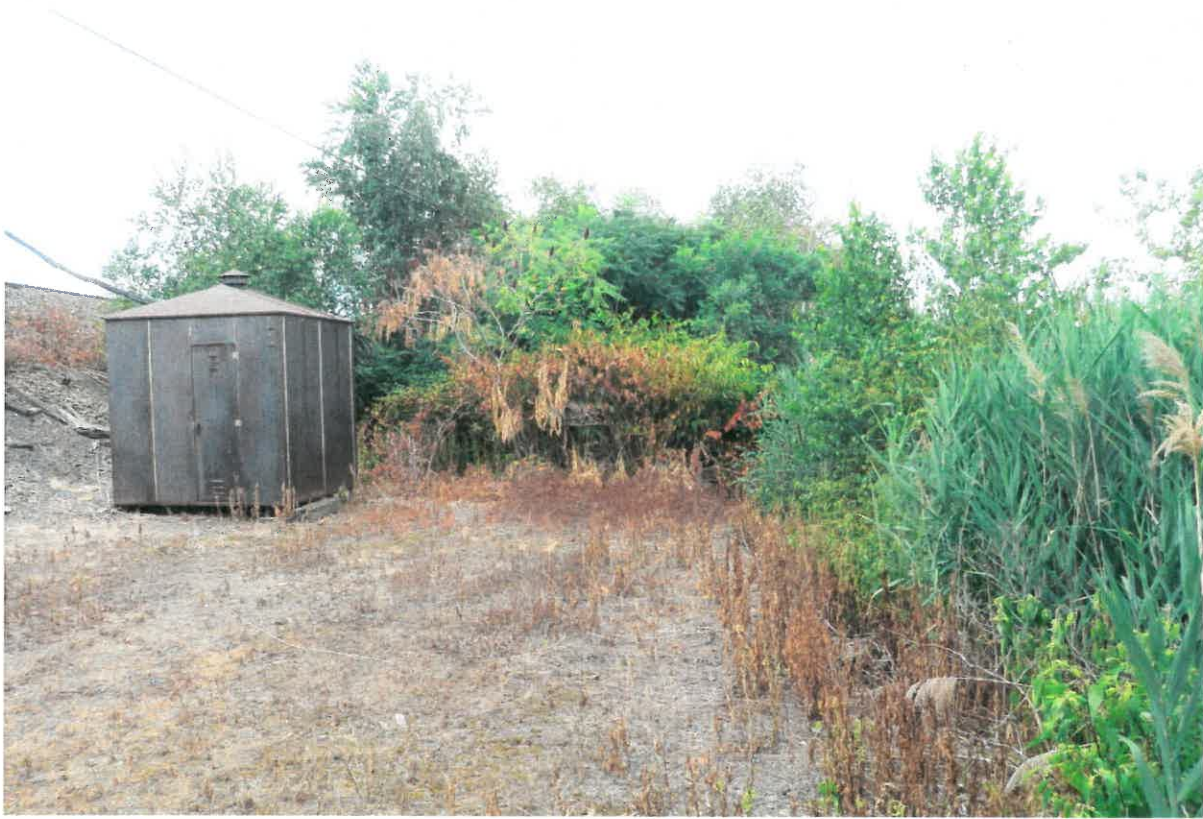
Photo A: View facing west of M&E Asset #2. Wetland line is at the toe of fill east (right) side of the asset. Area to the north of the asset is upland.

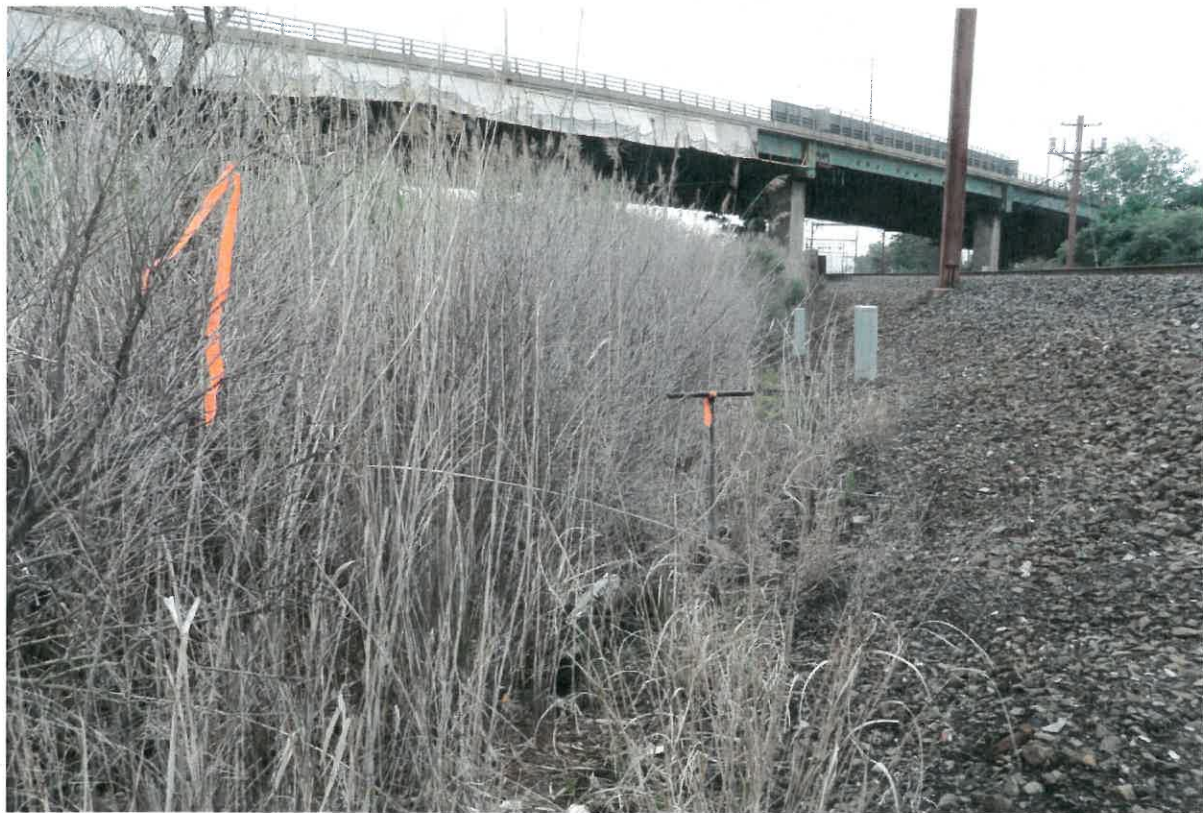
Photo B: View facing east of M&E Asset #3. Wetland line B follows the toe of slope.

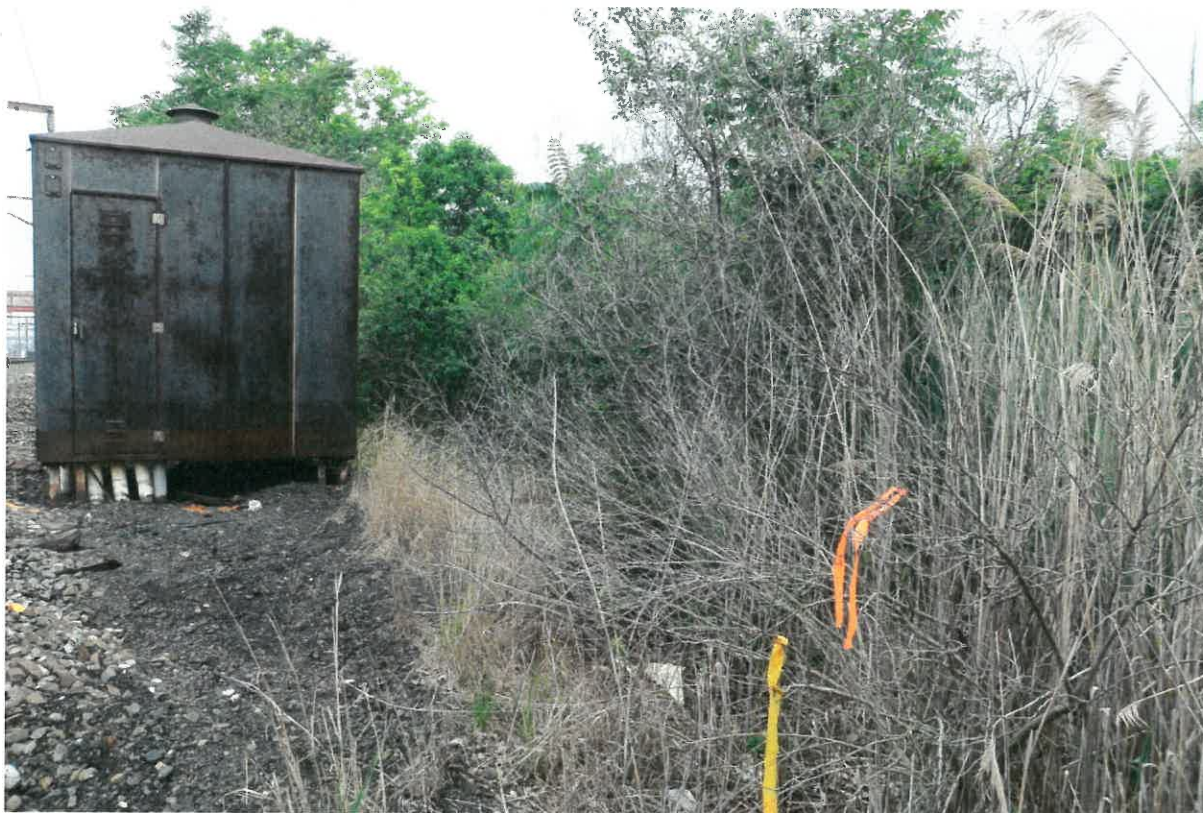
Photo C: View facing west of M&E Asset #4. Wetland line A follows the toe of slope within 5 feet north of the asset.

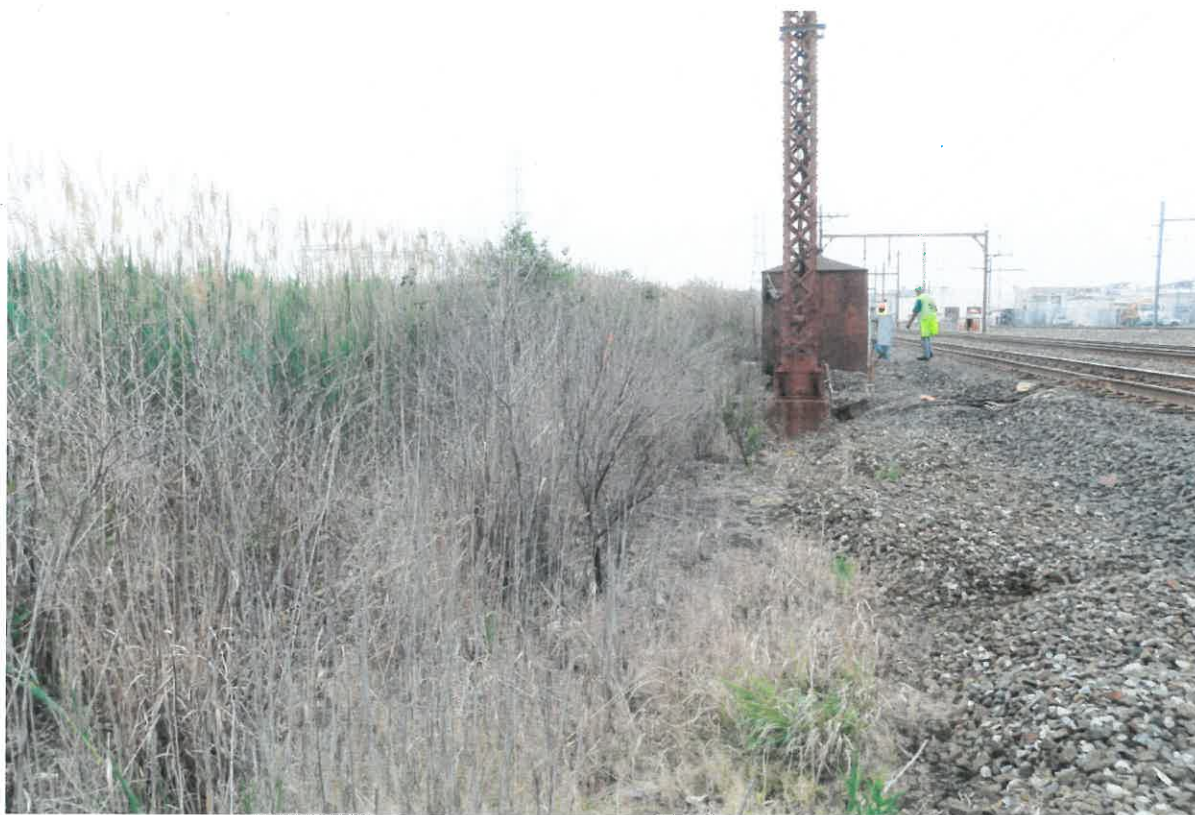
Photo D: View facing east of M&E Asset 10. Wetland line C is to the north of the asset and follows the toe of slope.

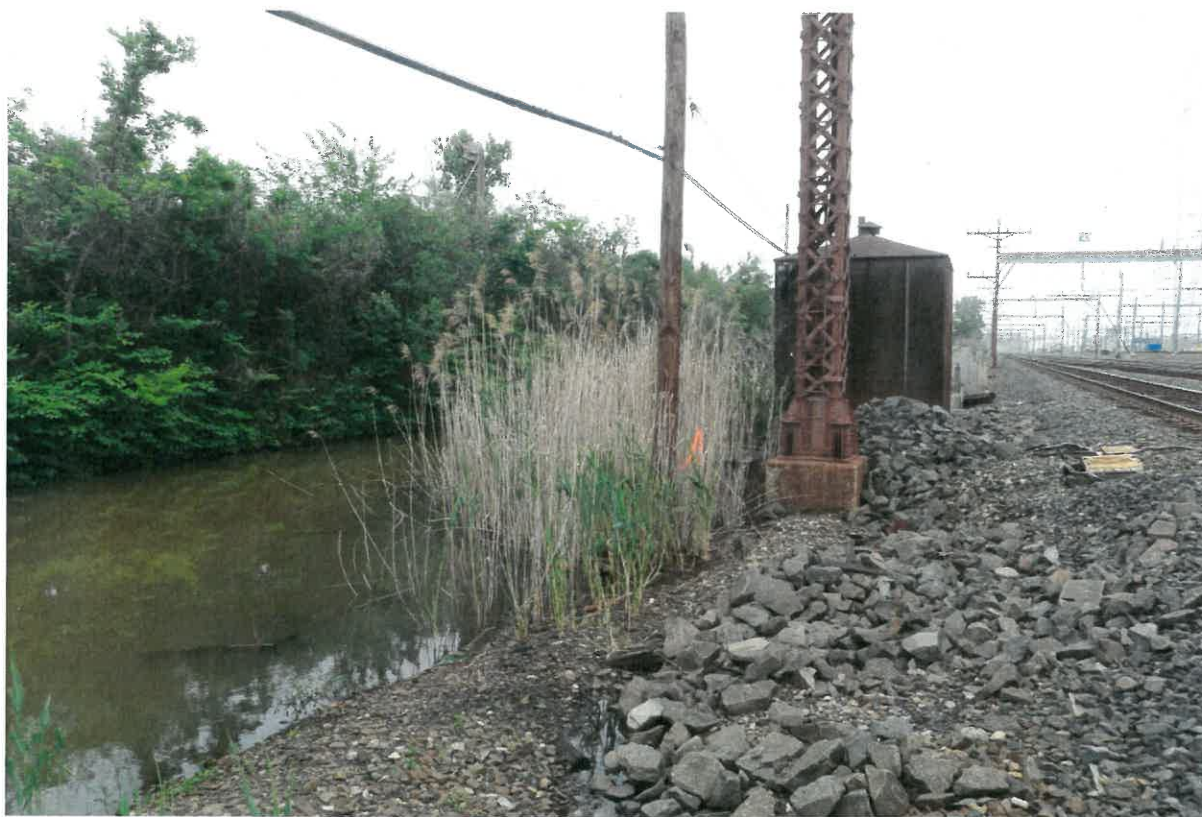
Photo E: View facing east of M&E Asset #14. Wetland line D has been flagged along the toe of slope of the rail road embankment.

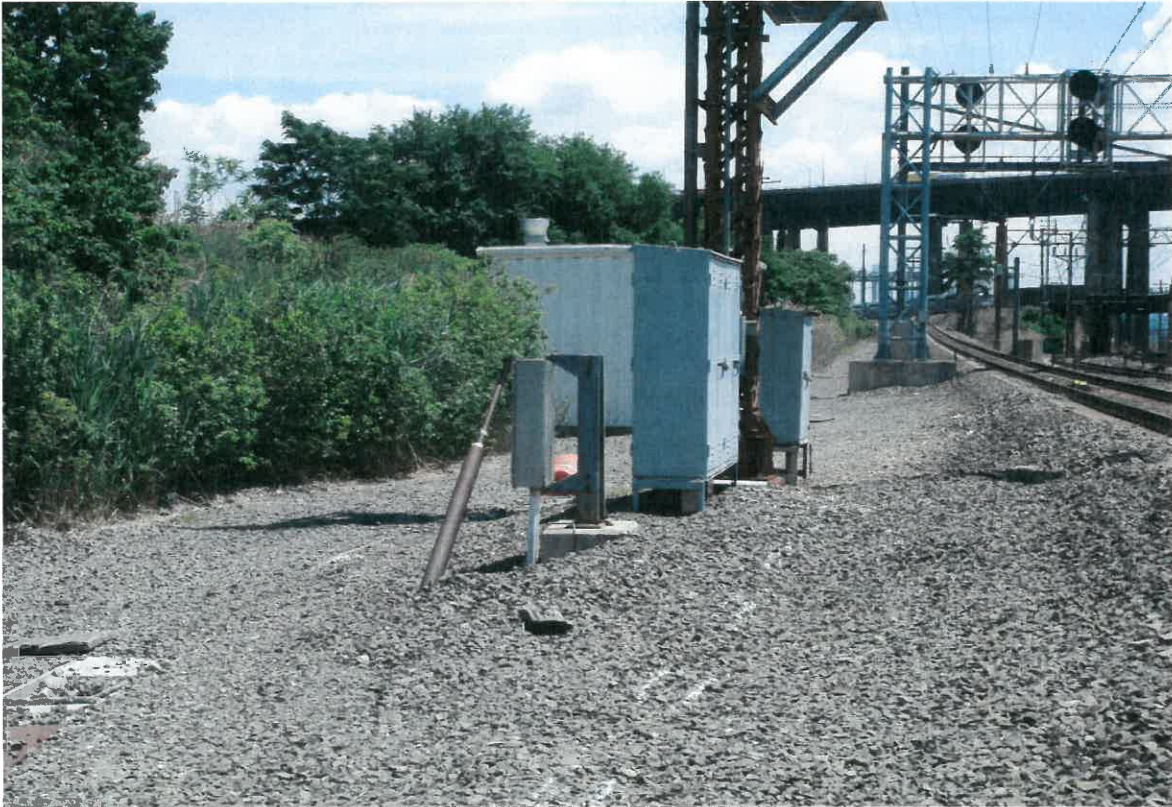
Photo H View facing northeast of M&E Asset 19. Wetland line H is located along the edge of gravel fill.

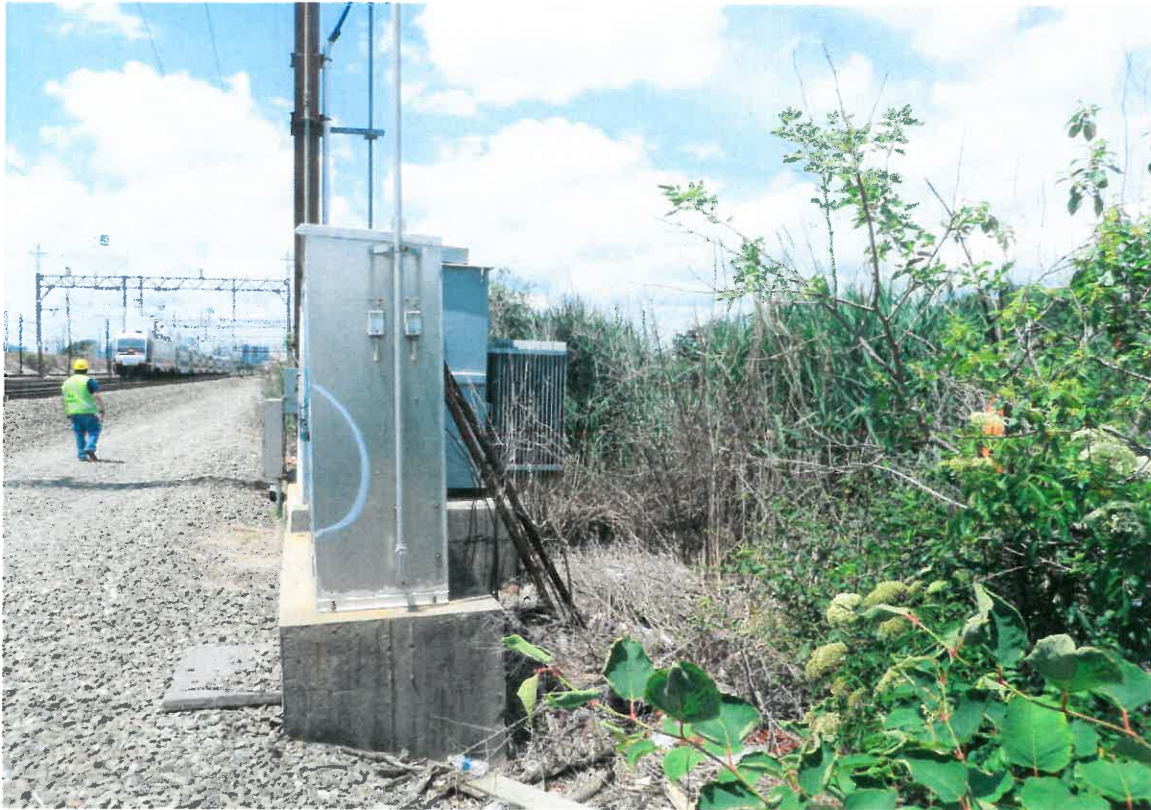
Photo I: View facing west of M&E Asset 20. Wetland line H extends behind this asset as well as asset 19.
